TRU WASTE PILOT RETRIEVAL

618-10/11 Workshop June 10, 2003 Ken Hladek

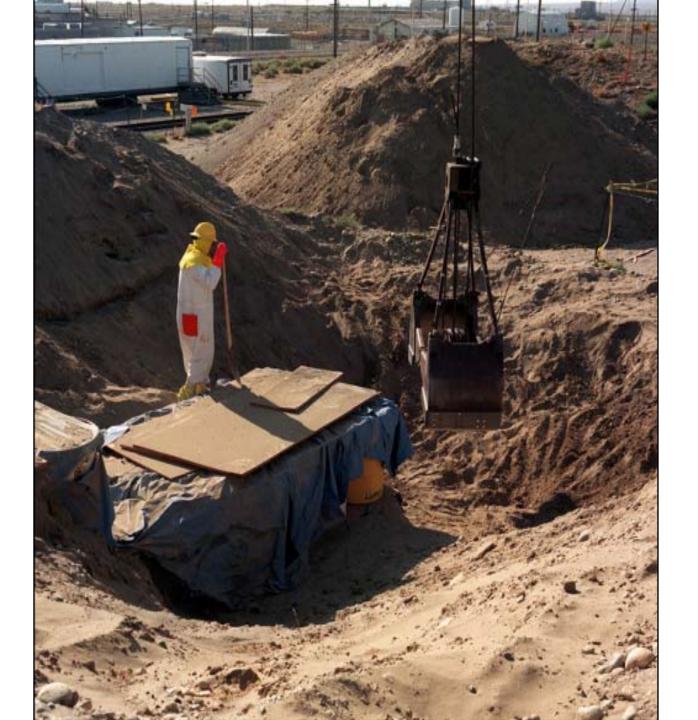
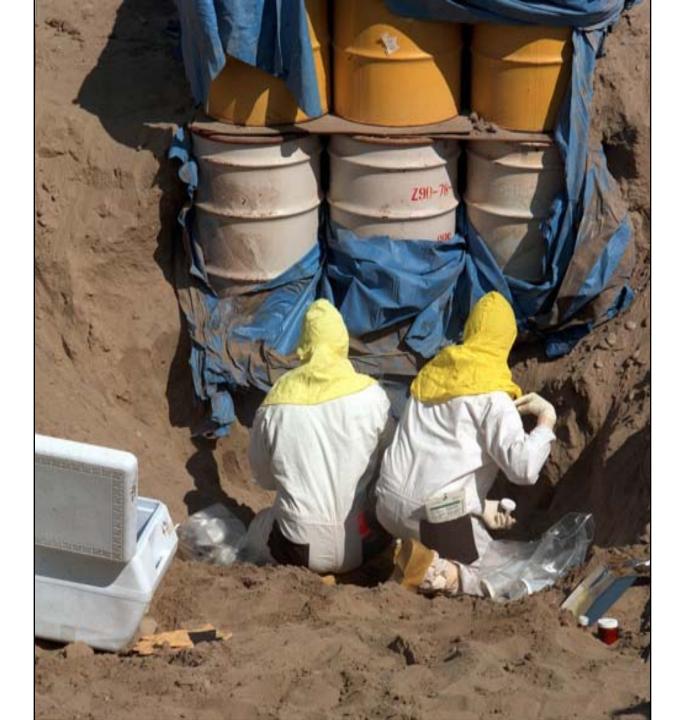
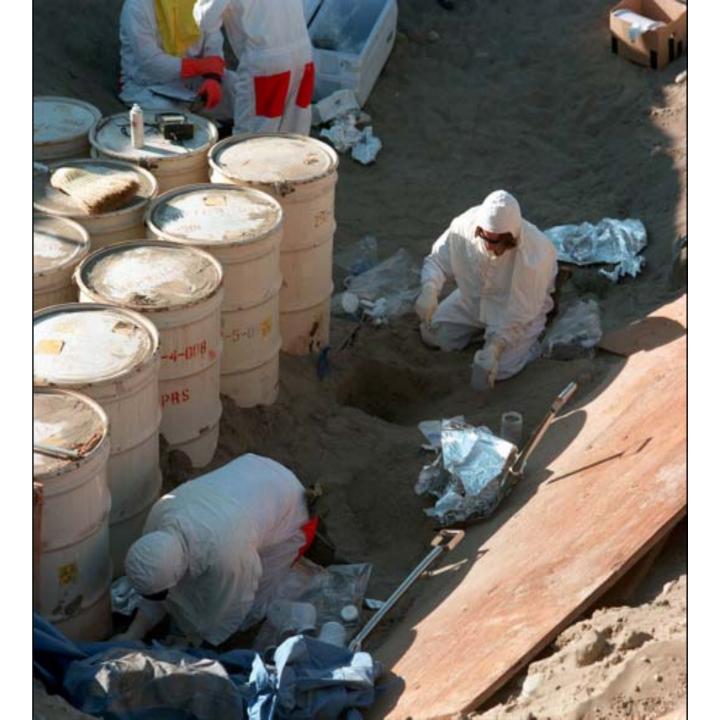
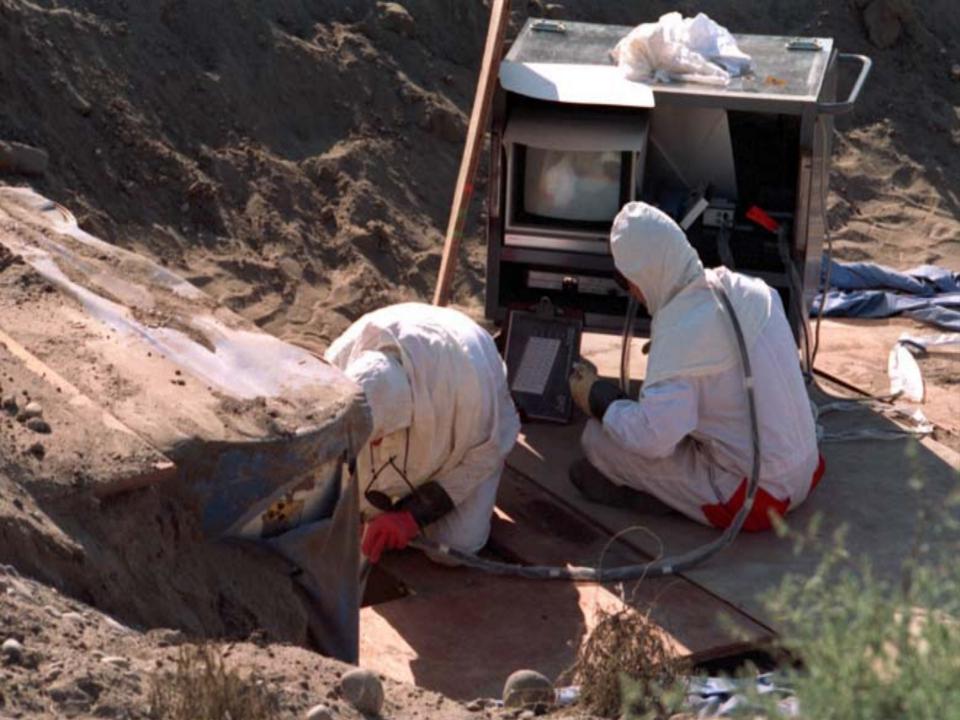
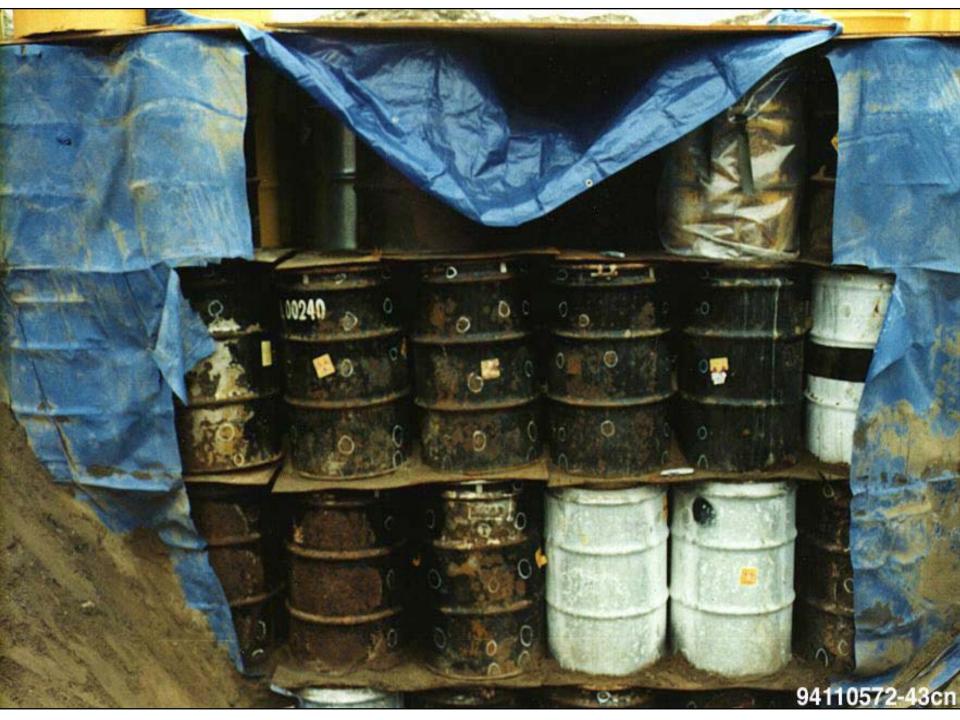
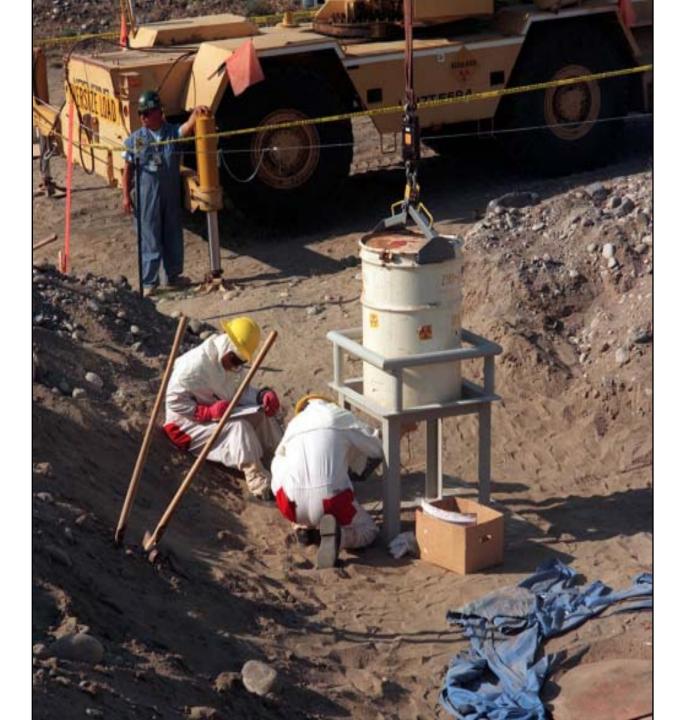
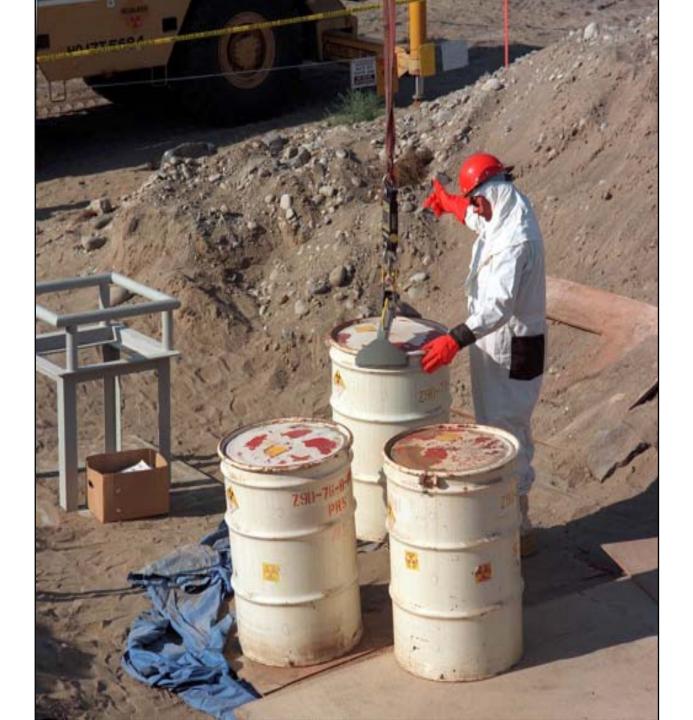
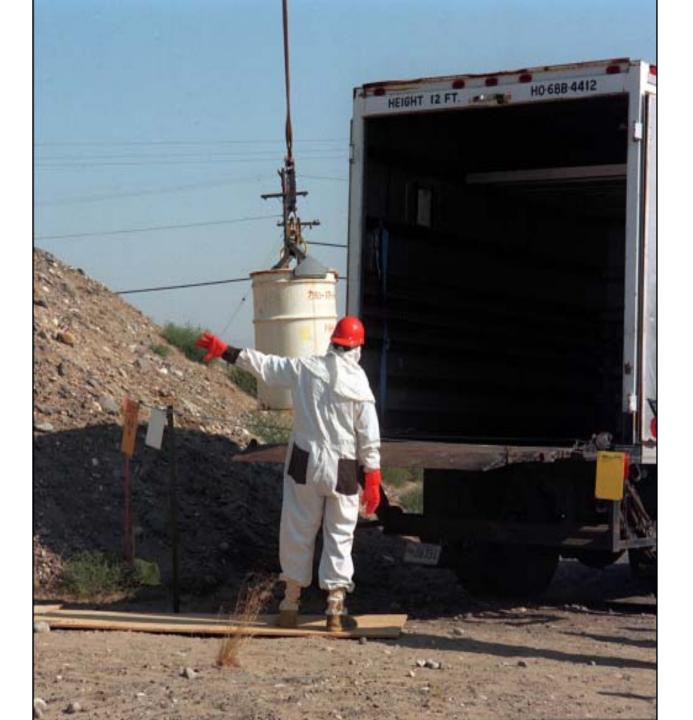
- Follow-on Activities (continued):
 - Cut Tarp Vertically: All OK
 - Drums look OK
 - Exposed additional drums on top two layers
 - Drums at corner of stack showed more surface corrosion
 - Initial field evaluated wall thickness readings showed small amount of uniform corrosion
 - Base of drums, in contact with plywood, showed some surface corrosion
 - Plywood in good condition

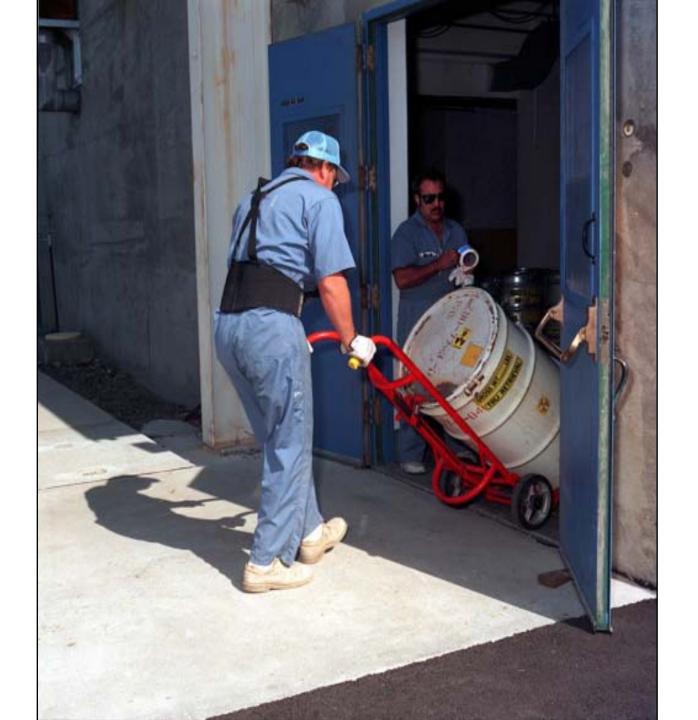
- Follow-on Activities (continued):
 - Retrieved a Total of 28 Drums from Top Two Tiers of Module
 - Funding constrained
 - Completed Retrieval Activities in October 1995
 - Obtained More Than 350 NDE Wall Thickness Measurements
 - No Final Report Issued
